**Standing Building Survey**  
of  
**Mission San Juan de Capistrano Chapel**  
Béxar County, Texas, USA

directed and reported  
by **Kevin Coffee**  
23 September 2011  
IMR-SAAN-5500-11145

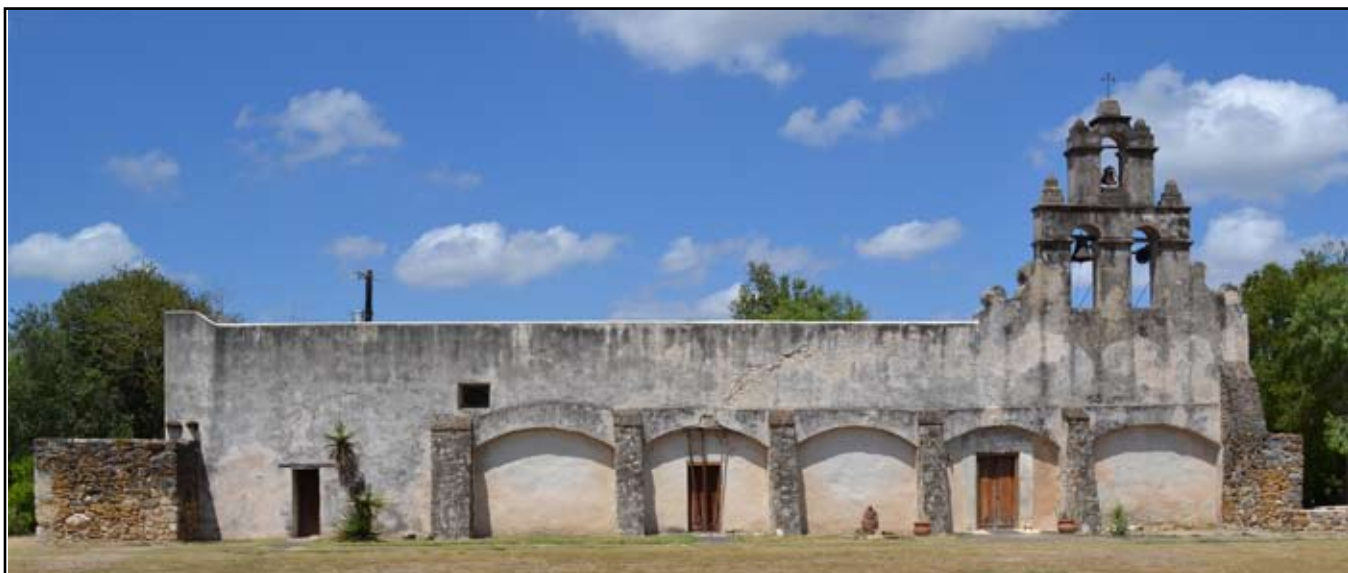
**Plate 2.** The east elevation of the chapel with adjacent boundary wall remnants to north and south, as viewed from the center of the Mission plaza. *Photograph by author.*

The east elevation (Plate 2 & Drawing 4) displays five arch details that span six pilasters/buttresses starting from the north end of the building. These arches are covered with cement, but in two areas where cement has fallen away the exposed stone beneath suggests voussoir construction (Plate 13, Plate 9). The façade below each arch is recessed and the arch extends out from the plane of the east face of the building, suggesting that each arch may be constructed to bear the weight of the wall above and/or to span a blocked opening below. Although the interior pilasters approximately align with four of these pilasters/buttresses (Drawing 3: Section E-E), there is no evidence of archway construction inside the chapel; thus, the arches may alternately be ornamental details.

Of special note in the east elevation are the middle and south door apertures and ocular window aperture, each of which is supported by timber lintels or lintel assemblages rather than masonry arches, such as at the main entry and the ocular window in the west elevation. The use of ashlar at the main doorway is also unique.

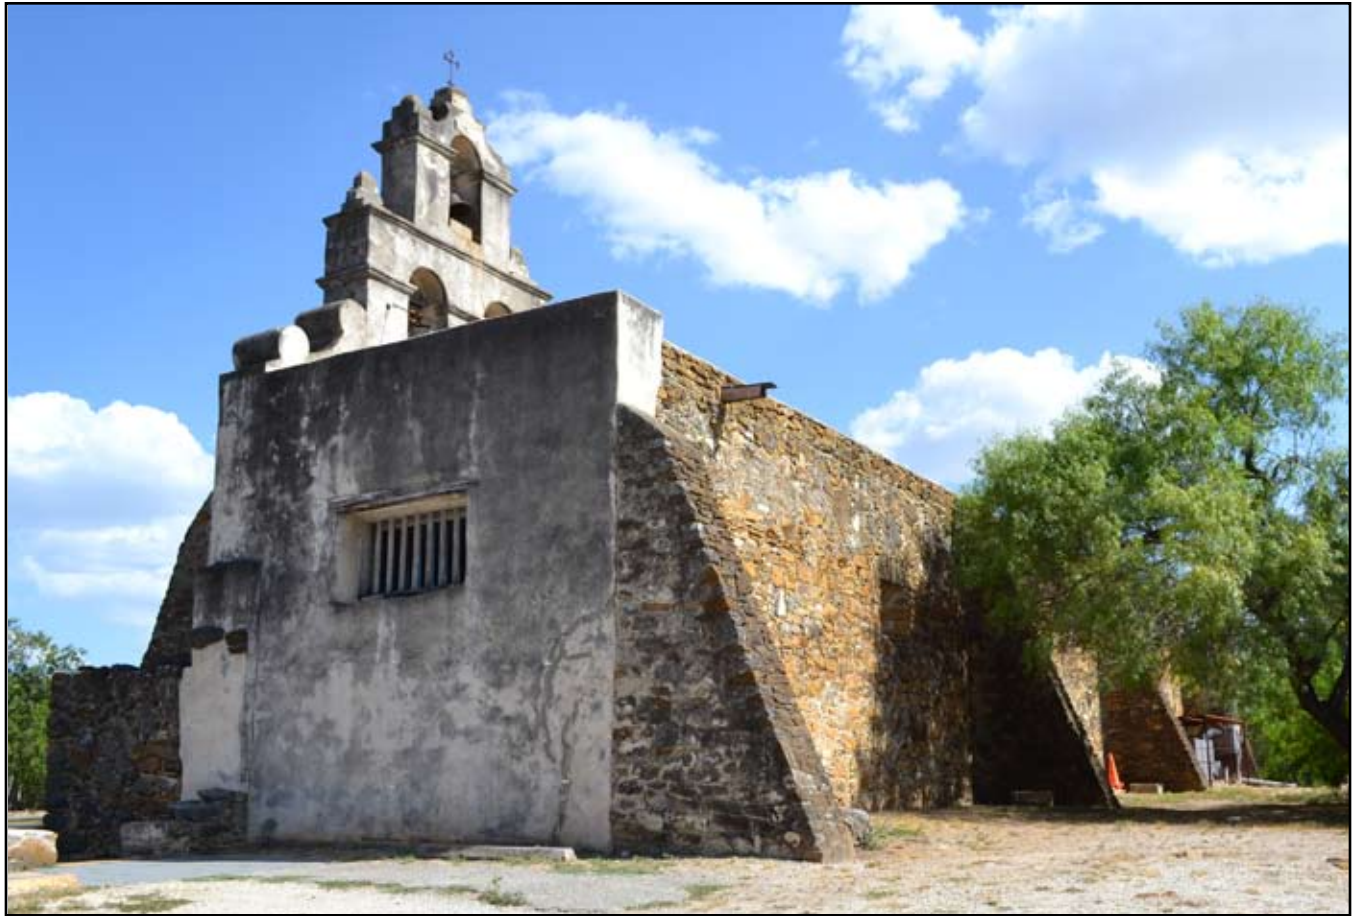
**Plate 3.** The north and west elevations of the chapel, looking southeast. *Photograph by author.*

The west elevation (Plate 3 & Drawing 5), which is not covered with cement, presents exposed masonry construction that exhibits multiple phases of construction and use. These are discussed at greater length in the analysis below. The elevation is comprised mainly of sandstone with limestone with random inclusions of smaller rubble stone across its length from north to south. Buttresses divide the elevation into three bays. The composition of variegated rubble increases greatly to the south end of the building. There is a visible pattern of aggregate cement in the middle and south bays of the building binding the smaller rubble in place.

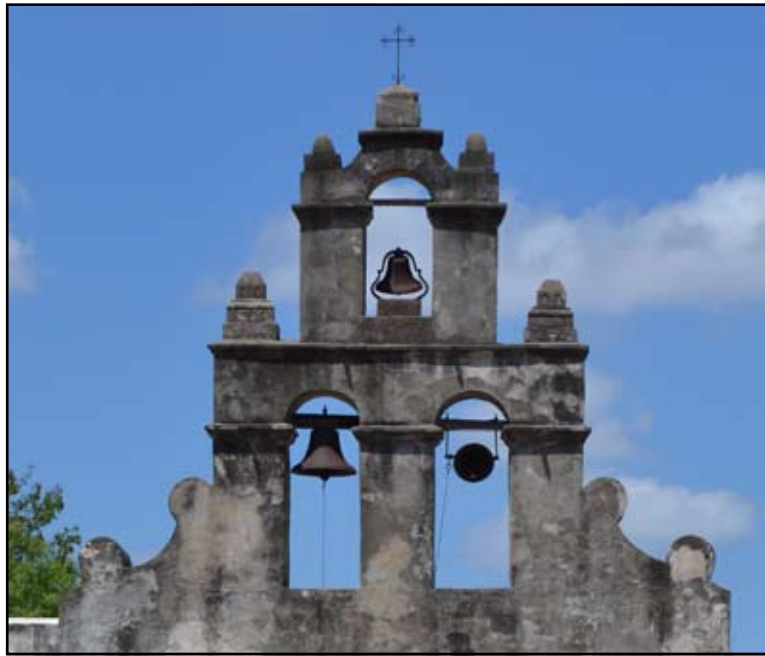
As noted, the bell tower rises above the northeast corner of the building. The bell arches have been completely covered in cement. The bell tower appears to lean to the east and is held in its present position by three iron rods that span the building to a location near the west parapet roof line (Plate 14).

**Plate 4.** The bell tower is comprised of two tiers of masonry arches now covered with stucco. *Photograph by author.*

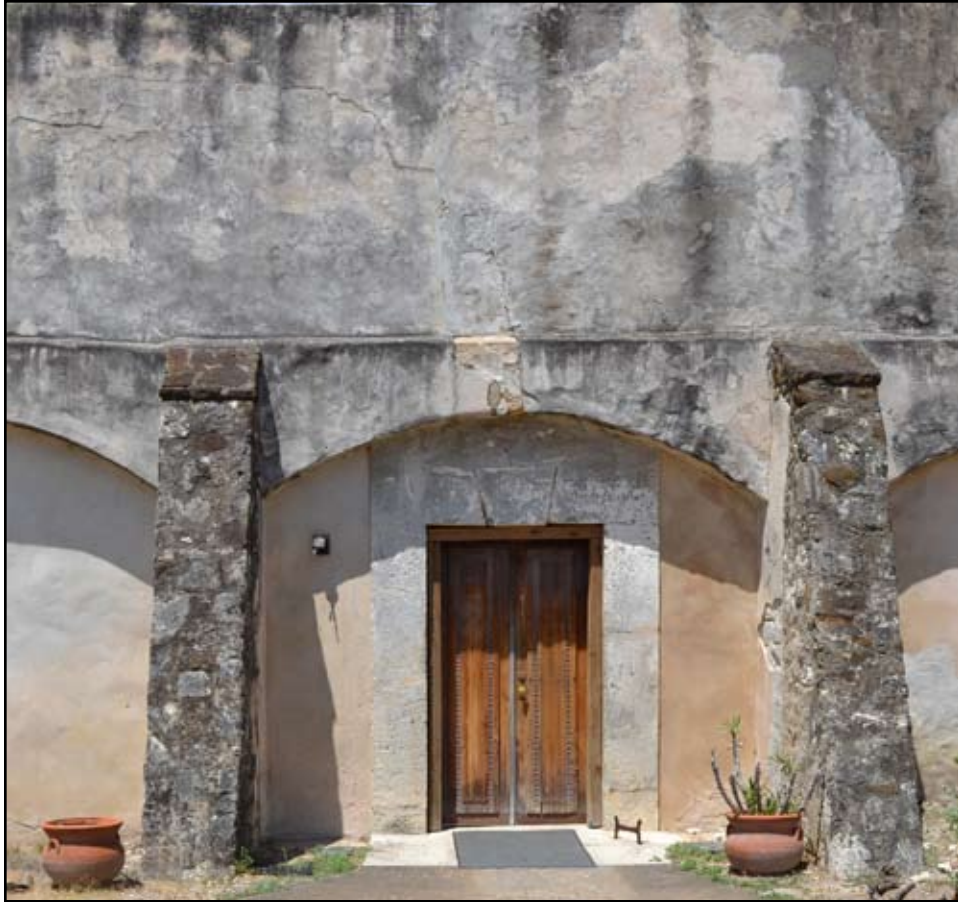
**Plate 9.** Main entry to the chapel. The C20 stucco cement was stained ca. 1963 and masonry buttresses were added ca. 1968 to several locations along the west and east elevations to provide 'historic' or 'antique' appearances. *Photograph by author.*

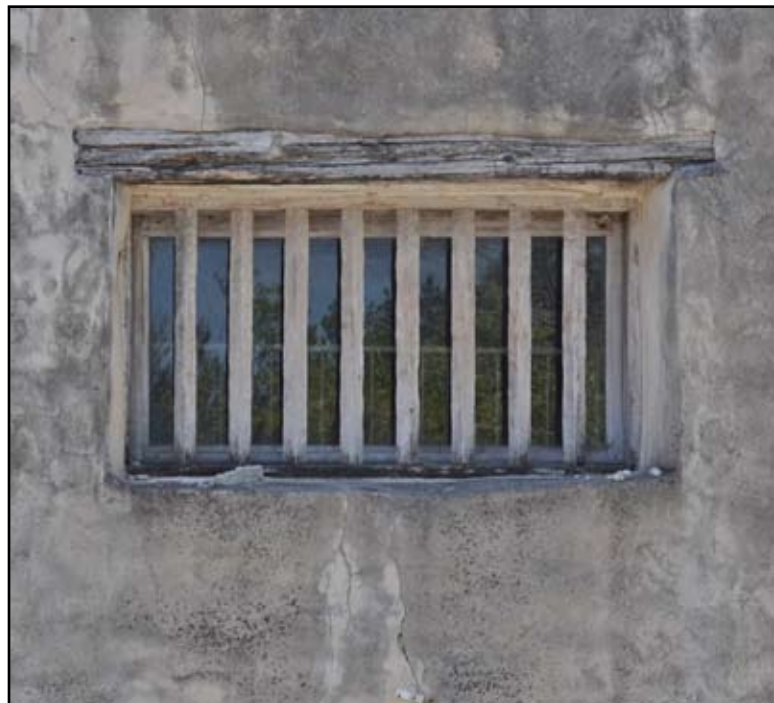
ever the adjoining wall remnant and the window aperture concur with phasing suggested in the east and west elevations. The window aperture is wood framed and supported by a compound wood lintel.

**Plate 10.** Window set into north wall. *Photograph by author.*

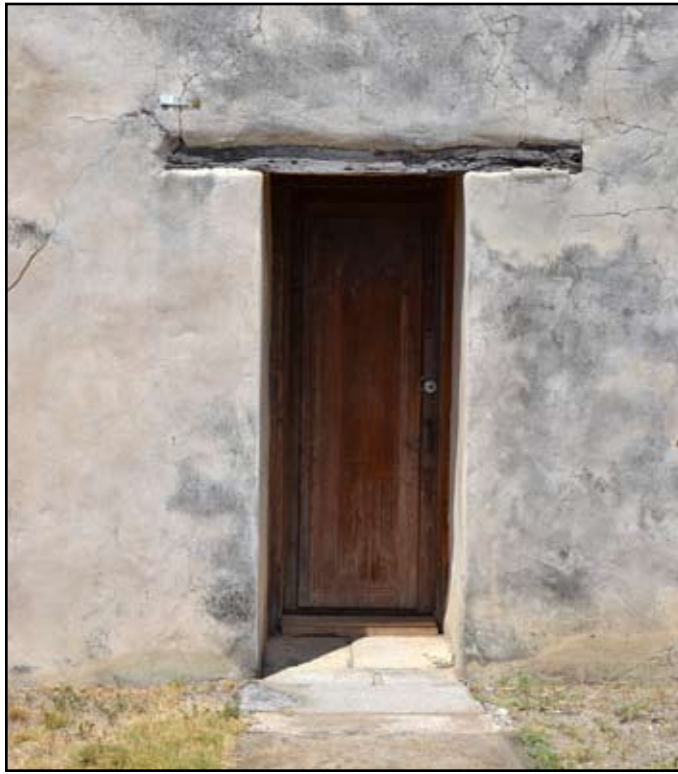
**Plate 11.** Sacristy door with timber lintel. *Photograph by author.*

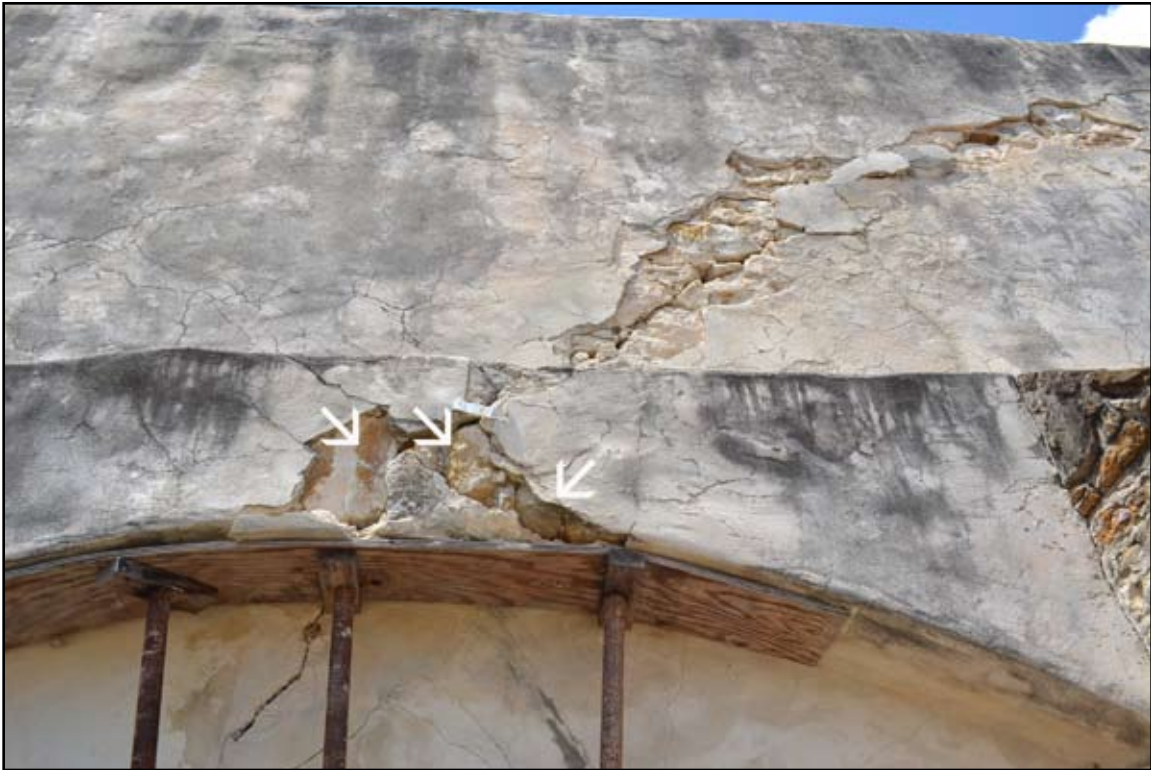
**Plate 13.** Detail above middle door in east elevation revealing arch masonry. *Photograph by author.*

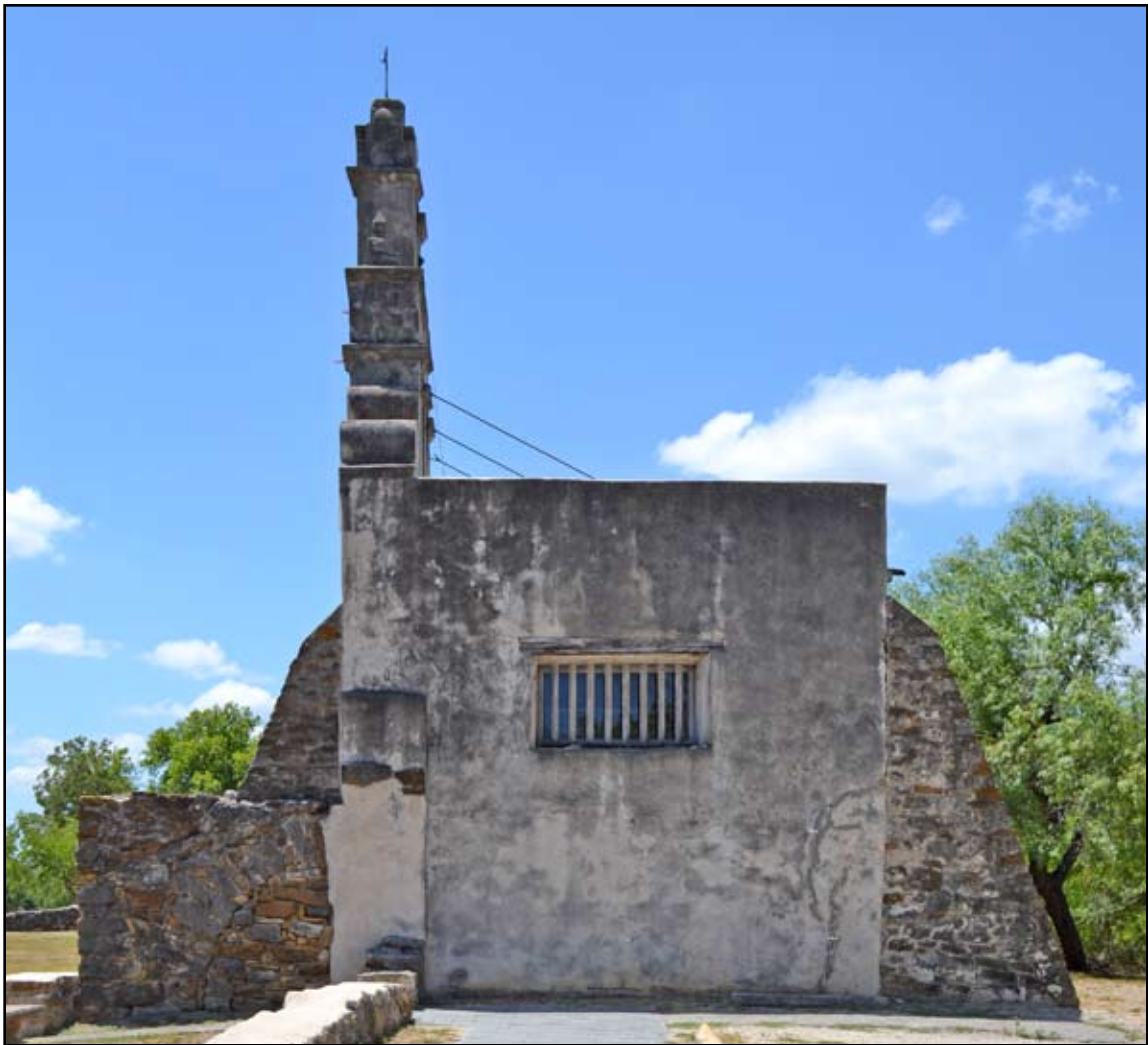
The north elevation of the chapel (Plate 14) is faced with cement, which conceals the masonry, how-

**Plate 14.** North elevation of chapel. *Photograph by author.*

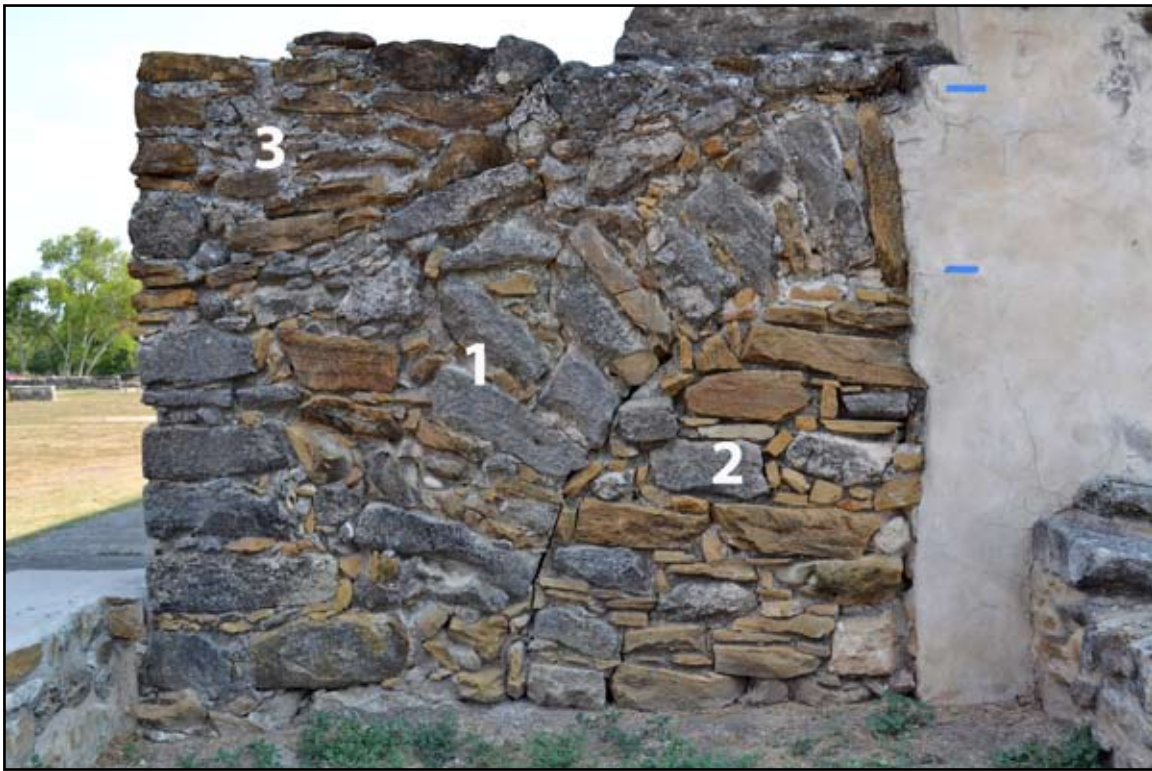
**Plate 15.** Buttress (1) at northeast corner of chapel that was blocked (2) and squared off (3) for use as a wall. *Photograph by author.*

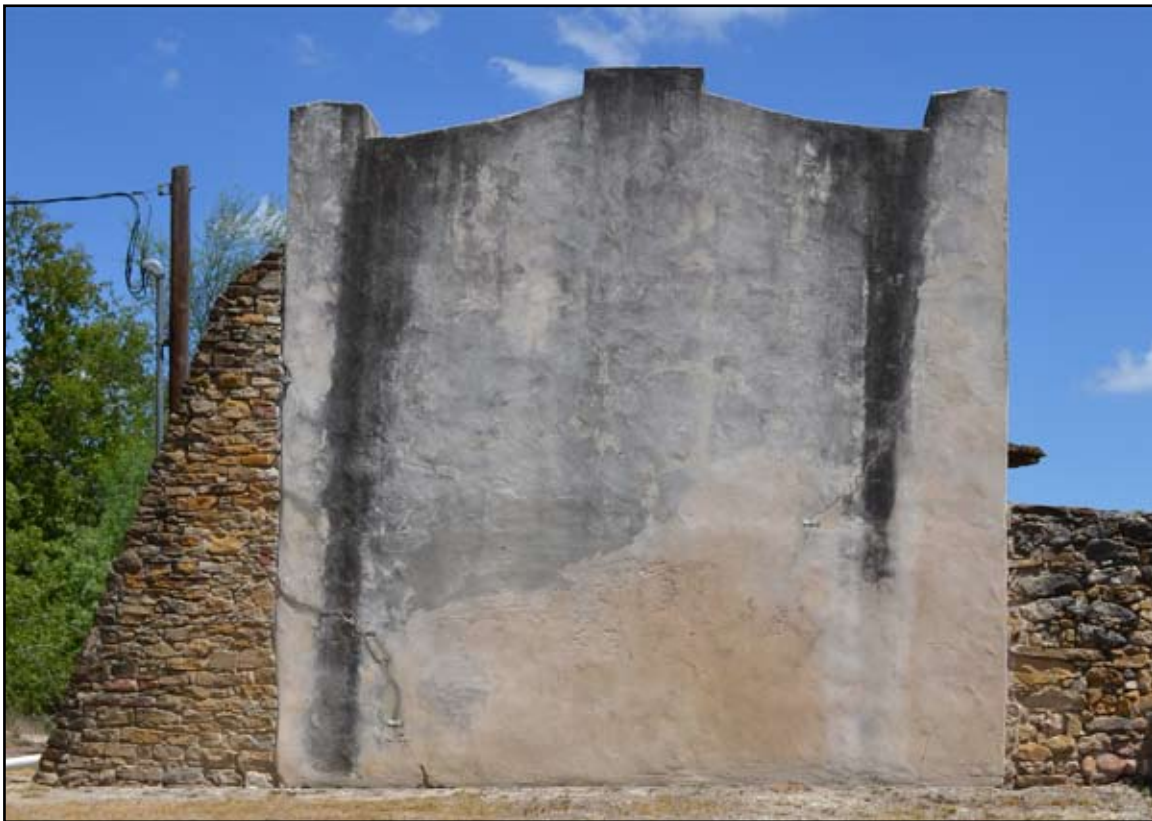
The south elevation is plain and completely faced with cement (Plate 16).

**Plate 16.** South elevation of chapel. *Photograph by author.*

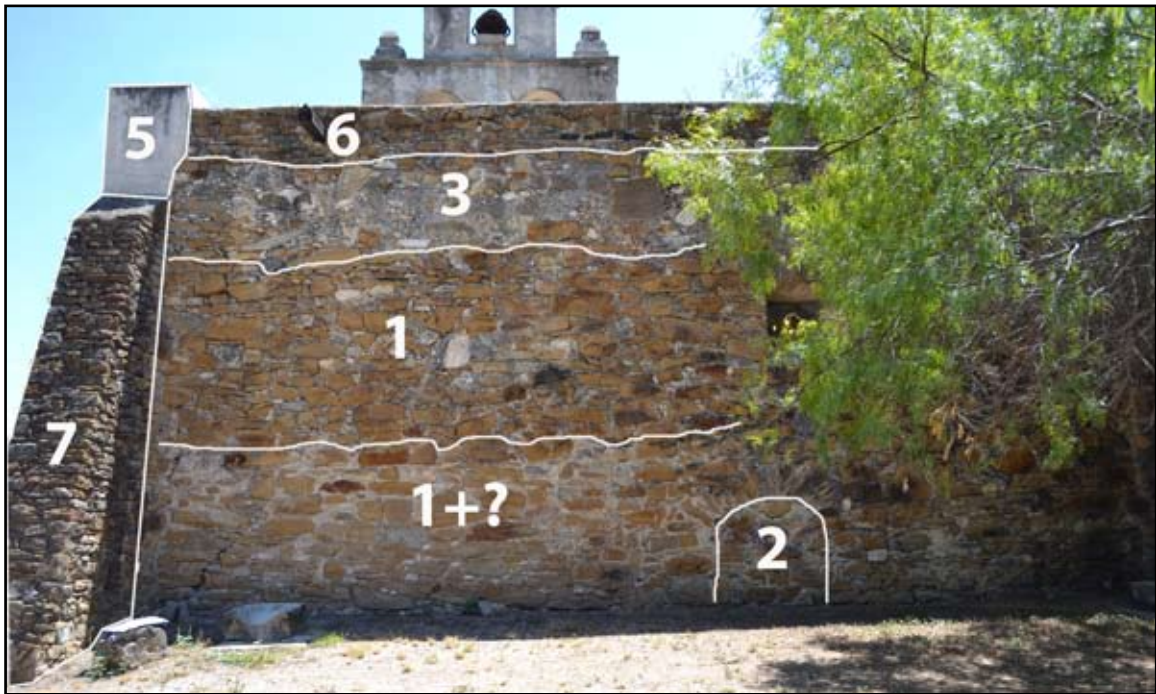
The west elevation, which is not covered by cement, presents exposed masonry construction that exhibits multiple phases of construction (Plate 23, 24 & 25). The first phase is seen in the predominantly sandstone construction that initially extended from grade to above the ocular window opening. This section of the wall appears as a systematically assembled unit rising past the straight arch of the window. The blocked-in archway below the window, the block sizes, assembly and mortar joints are consistent with the early- to mid-C18 construction technique used elsewhere at this site (Plate 27, 15, 8).

A lower part of the phase one sandstone wall [indicated by '1+?'] immediately north of the blocked archway displays an intermittent and partial application of mortar over the faces of some blocks. This appears to be an incomplete repair effort that was possibly intended to retain loose mortar between the sandstone blocks.

**Plate 23.** Phasing diagram of north bay of west elevation. *Photograph by author.*

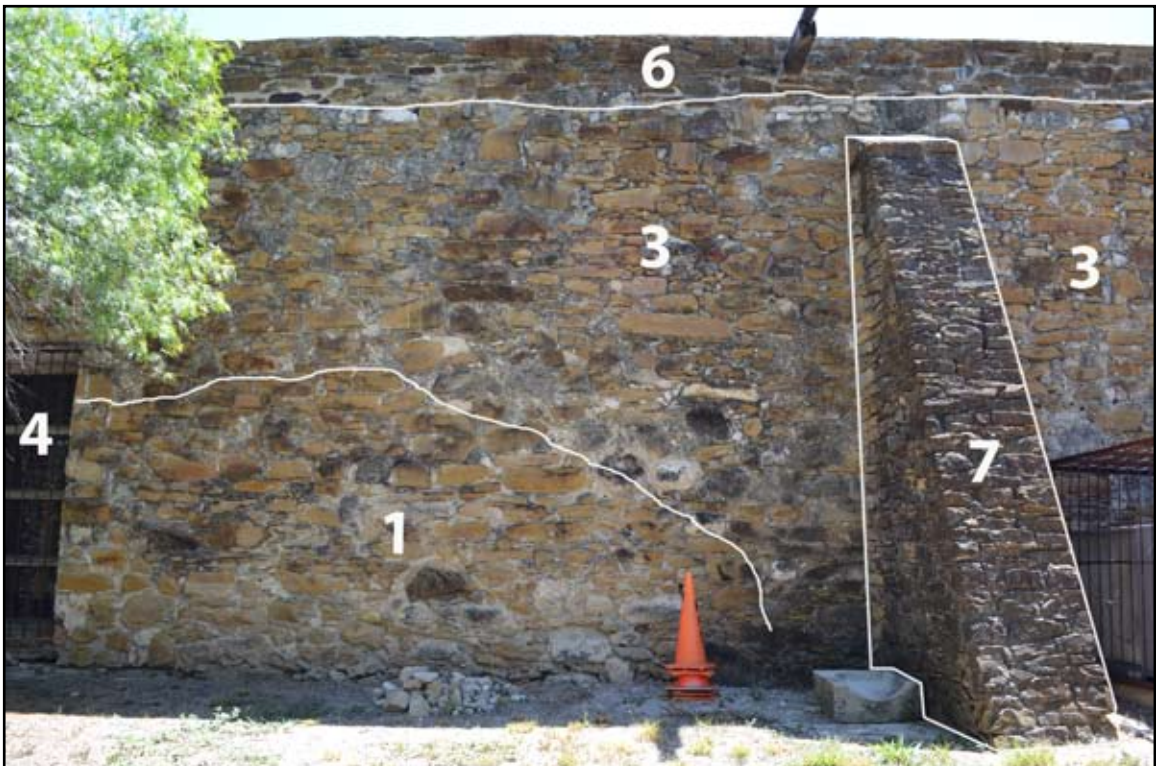
**Plate 24.** Phasing diagram of middle bay of west elevation. *Photograph by author.*

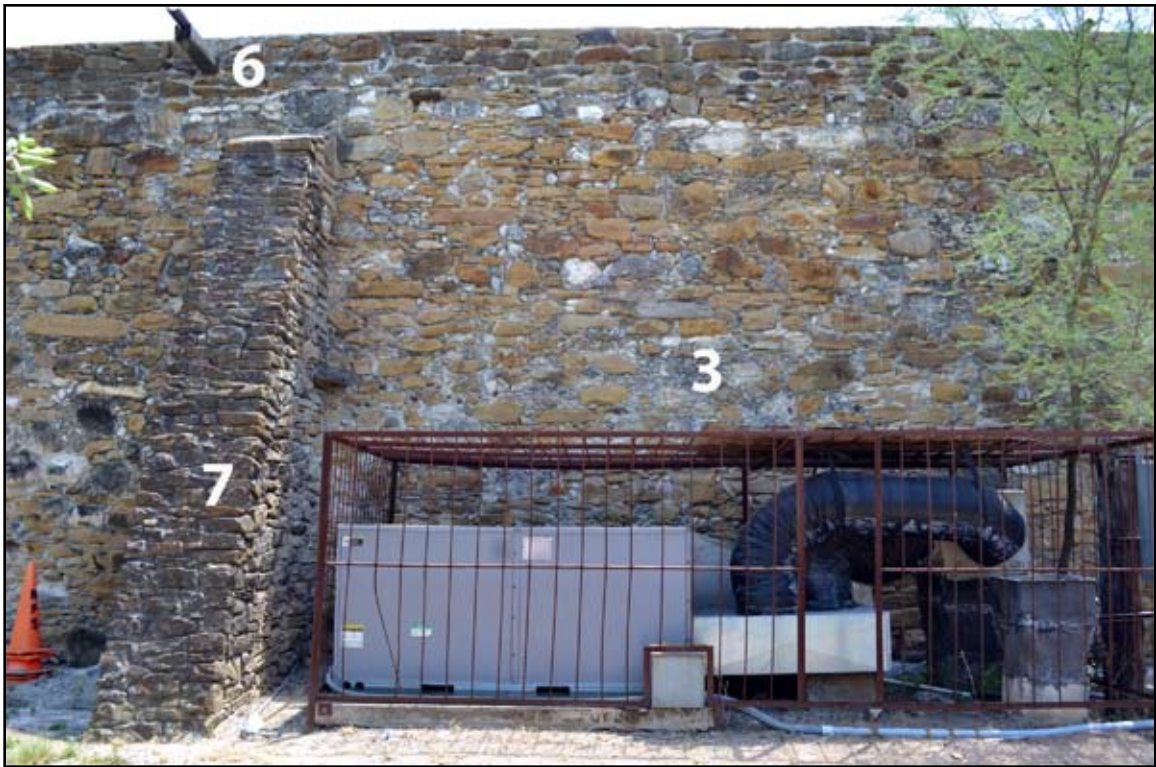
**Plate 25.** Phasing diagram of south bay of west elevation. *Photograph by author.*

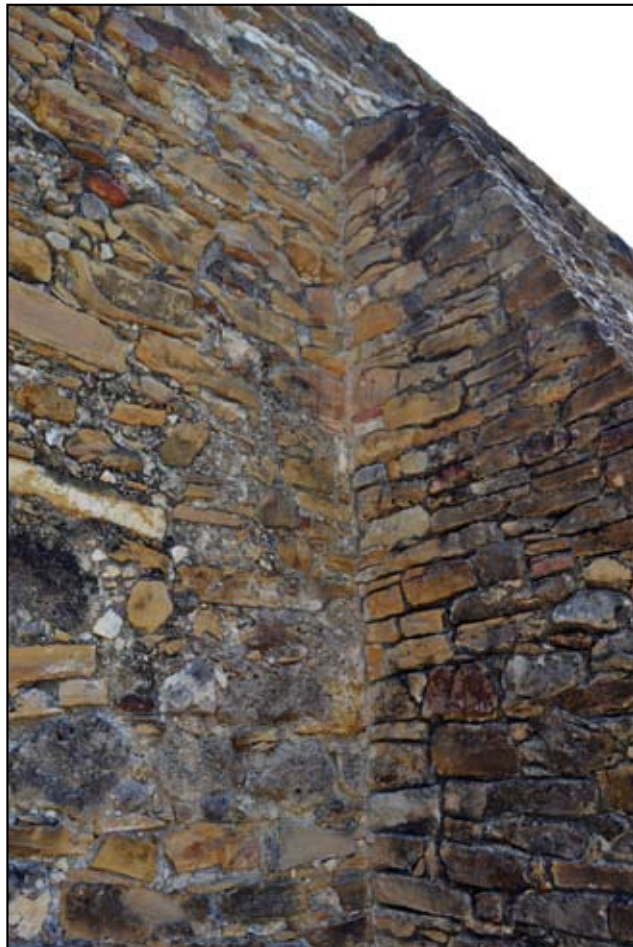
The third phase of construction is evident in the area higher up in the first buttress bay, approximately 4m above grade, appearing as an aggregate of highly variegated stones mixed with gravel and cement (Plate 26). This section appears as a significant repair to the wall and was perhaps an effort to restore it to a previous height, as it meets what appears to be a pre-existing sandstone section immediately south of it along the west elevation. This type of construction continues south along the west elevation into the middle bay, sloping downward toward grade through to the south bay.

**Plate 26.** Highly variegated stone [left] mixed with gravely cement in west elevation. *Photograph by author.*
