**Standing Building Survey**  
of  
**Mission San Juan de Capistrano Chapel**  
Béxar County, Texas, USA

directed and reported  
by **Kevin Coffee**  
23 September 2011  
IMR-SAAN-5500-11145

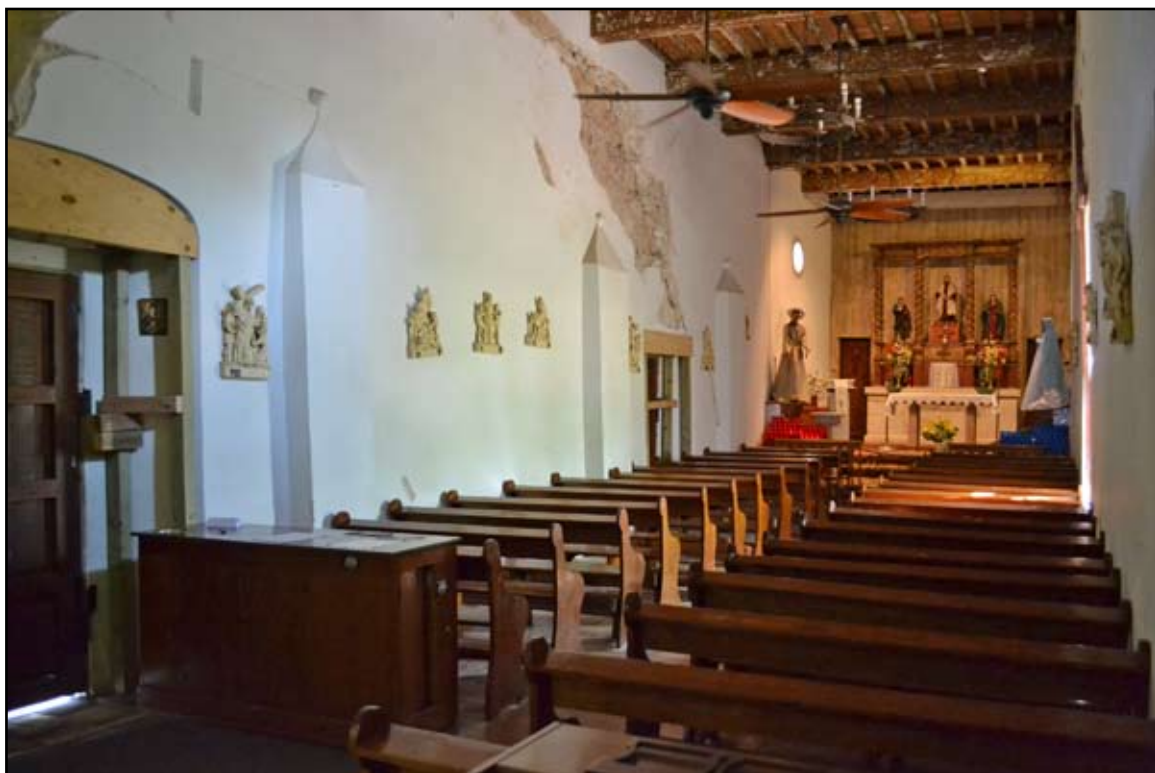
**Plate 5.** View from the back of the nave looking south toward the altar, as it appeared in mid-August 2011. *Photograph by author.*

The chapel building is comprised of two cells, the major cell includes the nave and sanctuary and is divided from the smaller sacristy cell by an interior wood-framed wall. The sanctuary and altar are elevated and at the south end of the major cell. The interior walls are plastered. A series of four pilasters are spaced across the interior east wall and rise approximately 3m from the present floor. The floor is vitrified terra cotta tile throughout. The ceiling/roof is comprised of wood beams that traverse the width of the building, above those are run longitudinal rafters, which are clad above with wood planks (Plates 5 & 6).

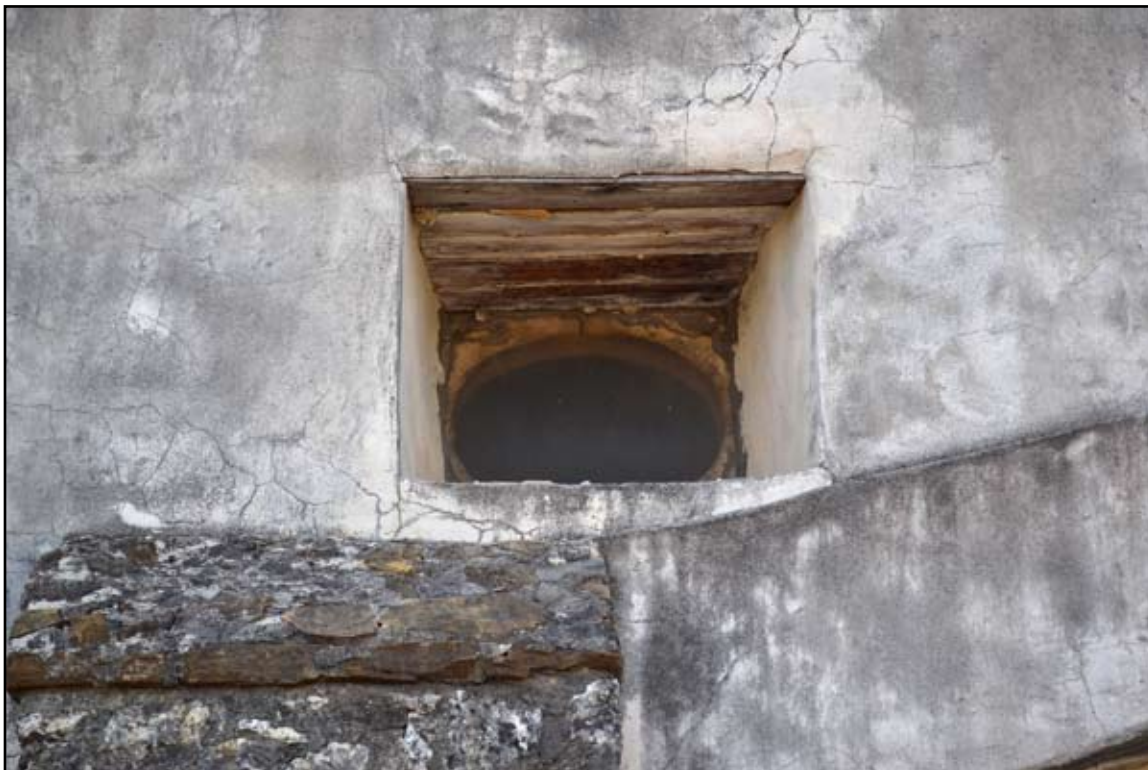
**Plate 7.** Ocular window at southeast corner of nave. *Photograph by author.*

Window openings occur in four locations. Two elliptical/ovoid openings are built into masonry apertures at either end and on opposite sides of the nave; the east aperture lintels are timber and approximately 4m above the floor (Plate 7), the west aperture arch is formed by a straight masonry arch and is approximately 3m above the floor (Plate 8). A rectangular window opening supported by a timber lintel is located in the center of the north wall with its sill approximately 3.1m above the present floor (Plate 10). A larger, 2.55m tall rectangular window supported by a timber lintel is located in the middle bay of the west wall immediately south of the buttress. This window sill is approximately .65m above the interior floor level and nearly at grade externally. A 30cm x 50cm aperture, which currently provides for

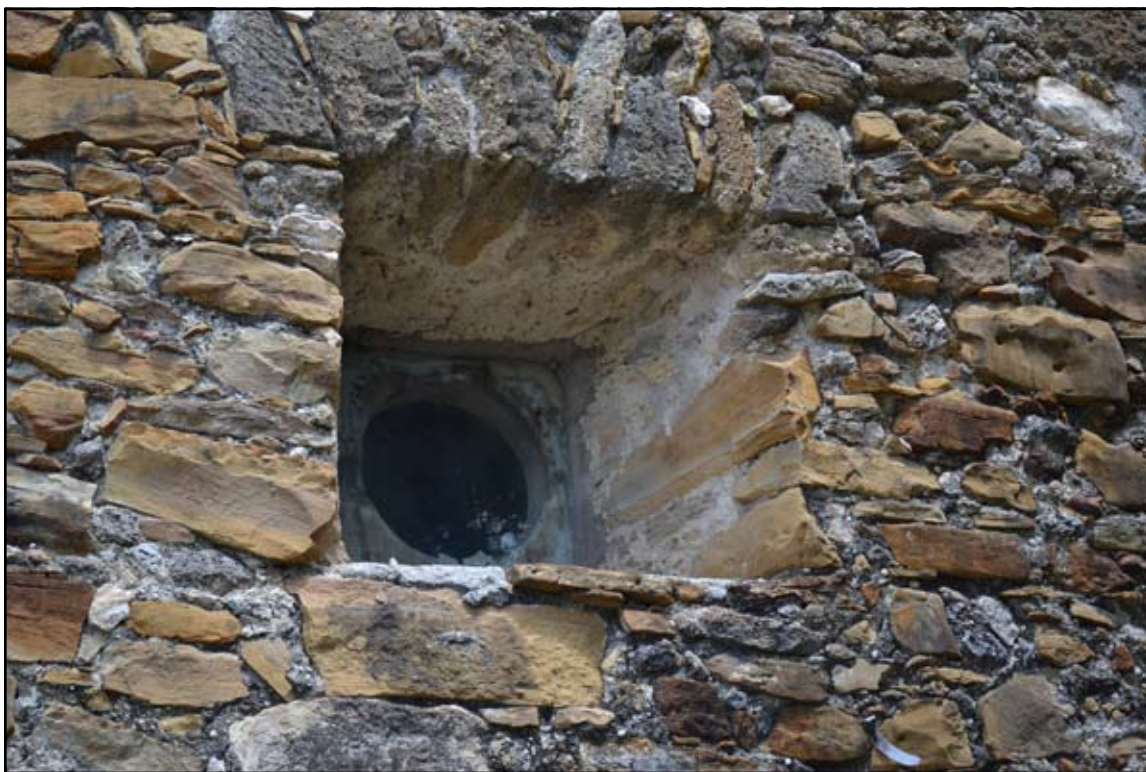
**Plate 8.** Ocular window at northwest corner of nave. *Photograph by author.*

Those parts of the chapel that feature complex masonry such as the west ocular window, the northeast buttress, the archways along the east elevation and the blocked-in arch on west elevation demonstrate a distinct architectural and engineering concept (Plates 8, 15, 27). The simpler wooden framed windows demonstrate a different construction technique very likely responding to economic pressures and constrained resources, as is the use of random salvaged stone to rebuild collapsed walls. The first approach antedates the second.

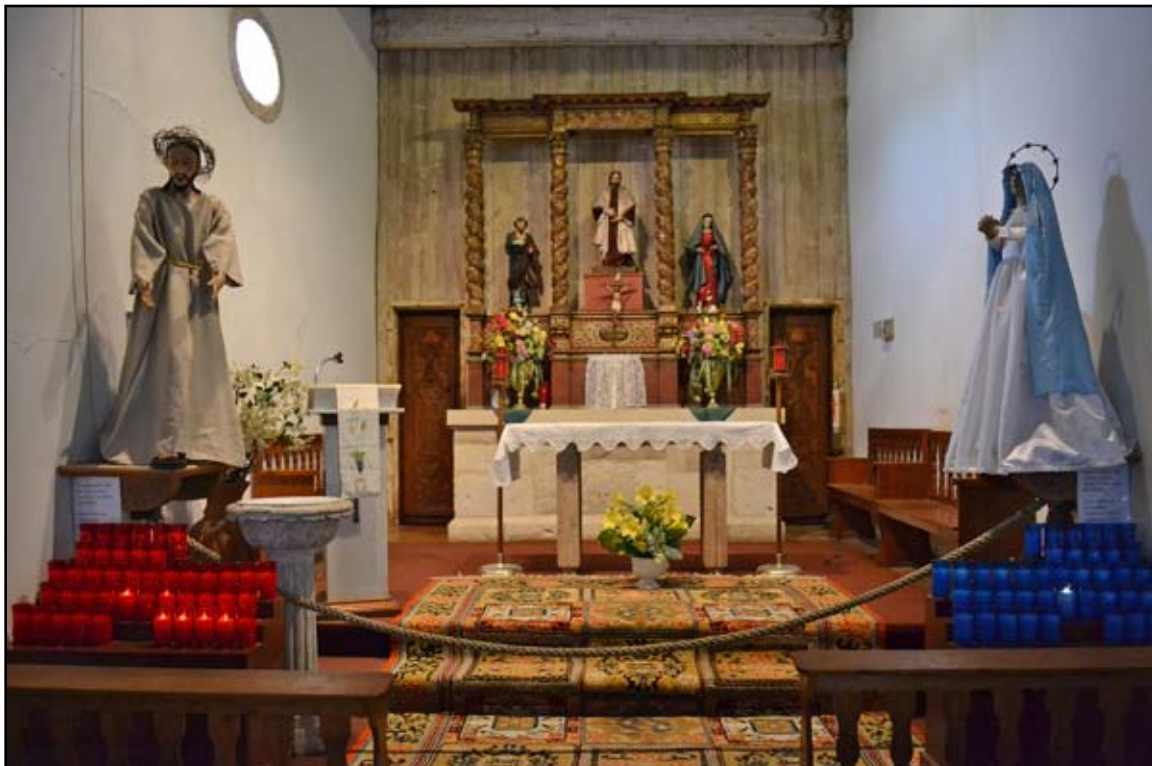
**Plate 12.** Chapel interior looking south. The sanctuary and sacristy are separated by a wood framed wall; two doors into the sacristy flank the limestone altar. *Photograph by author.*

The three external doorways are located in the east elevation. The principal entrance near the north end is framed by ashlar limestone blocks; those across the top are secured with a keystone (Plate 9). The middle door, providing egress near the sanctuary, is wood framed. The third doorway, providing access to the sacristy, is supported under a single timber lintel (Plate 11). Inside, two narrow wood doors flank the altar and pass through the partition that separates the sanctuary from the sacristy (Plate 12).

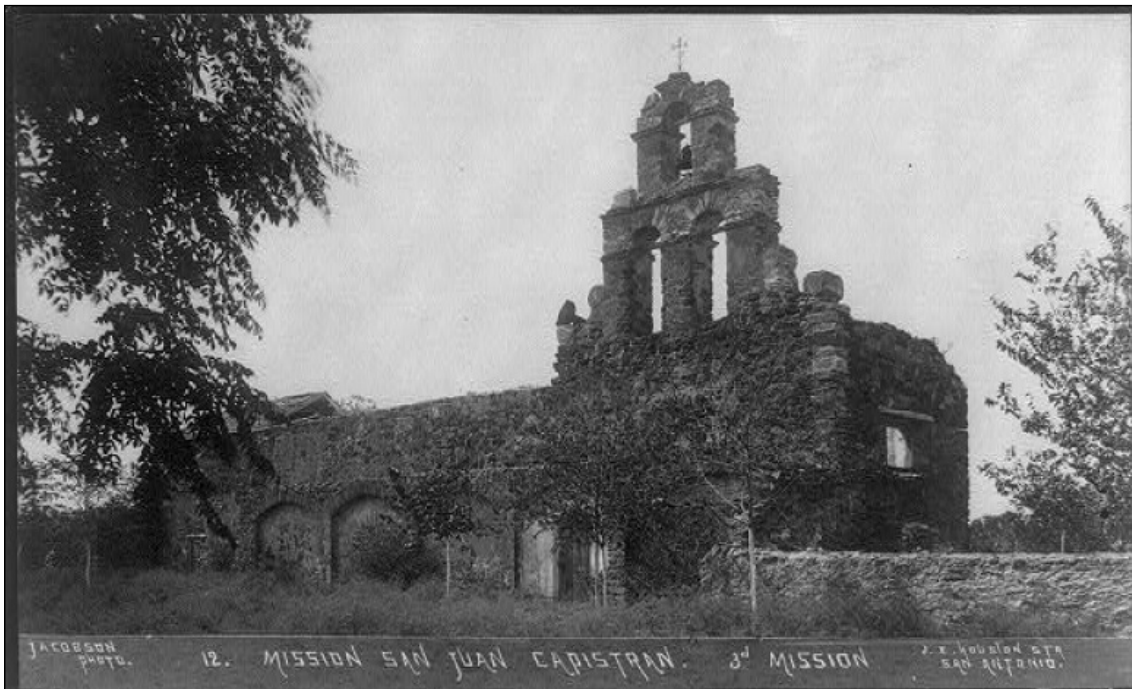
**Plate 18.** Photograph of chapel from northeast by M. Jacobson, ca. 1890. *Courtesy Library of Congress. Prints and Photographs Division. LC-USZ62-41542.*

A photograph by M. E. Jacobson ca. 1890 provides an image of the chapel after the roof and, apparently, a section of the west elevation had been damaged by a severe storm (Plate 18). The masonry of the elevation and bell tower is clearly visible.

The masonry cement was possibly intended to help hold the stonework in place as well as provide a 'historic' appearance to the building. This cement was apparently first applied earlier in C20; stain was applied in the 1960s (Plates 18, 28, 9). Similarly, the buttresses along the west wall and the buttresses along the east wall aligned with the five arches and the end walls are also 'historic' re-creations, but later C20 additions.

8. Note that this parapet extension is not in place in the 1936 HABS photo of the elevation, Plate 28.
9. Plate 18 shows a wall running north from the chapel which indicates that the wall was salvaged for stone after 1890. The photograph also shows the arched buttress without a squared shoulder.

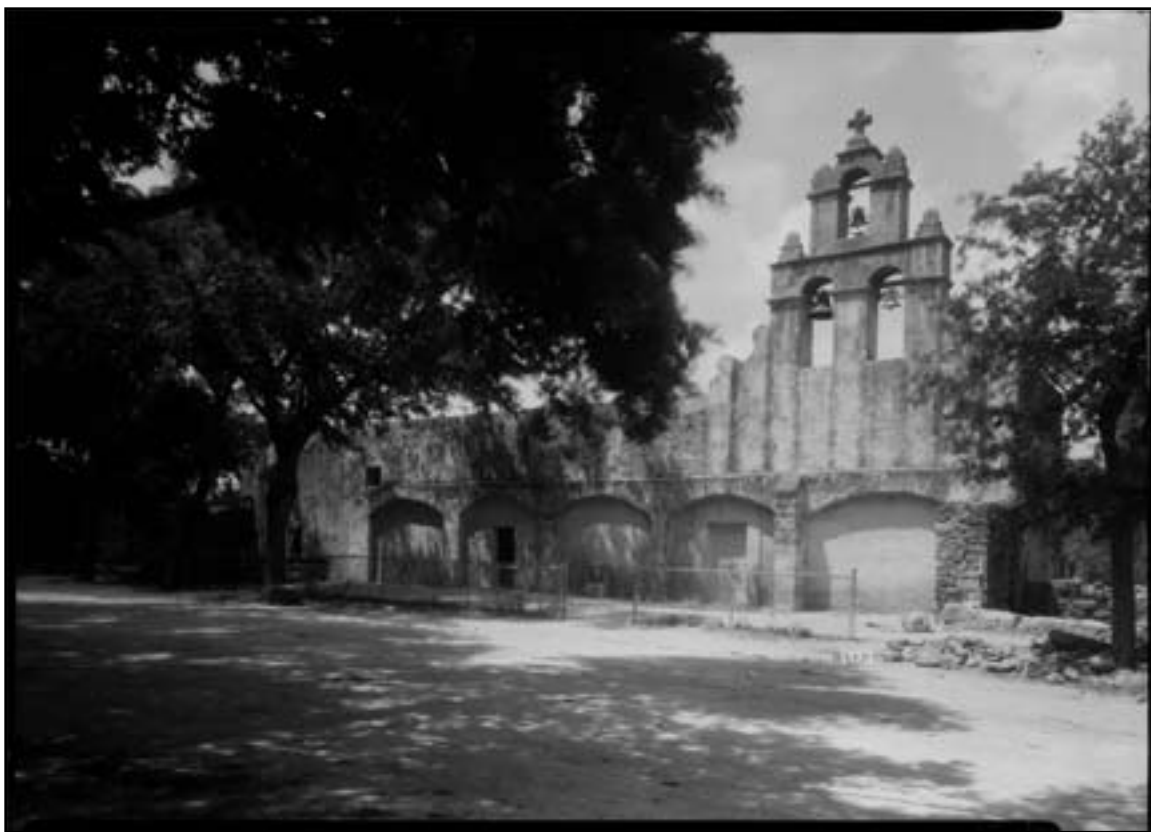
**Plate 19.** San Juan de Capistrano Chapel in 1936. Photograph by Arthur W. Stewart. Courtesy Library of Congress. Prints and Photographs Division. HABS TEX.15-SANT.V3-2.

A 1936 HABS photograph shows the exterior of the chapel 28 years after renovations by the Diocese, including masonry cement (Plate 19).

The third phase exhibited in the west elevation demonstrates a major rebuilding of the chapel wall using random rubble visibly distinguishable from the original sandstone and limestone blocks used earlier. This is interesting for multiple reasons. Apparently, part of the west elevation collapsed or was taken down after the privatization of the Mission in C19. Whole sections of the mission were sold as building supplies promptly in 1824; a process that continued for some time thereafter (c.f. Weber 1981). From at least 1855, San Juan de Capistrano was subsidiary to San Francisco de la Espada with Father Francis Bouchu assigned responsibility for both. Over the next 50 years, Bouchu devoted his attention and personal finances to purchasing property at and renovating the church at San Francisco de la Espada (Almaráz 1989:26-27). In consequence the chapel at San Juan de Capistrano was likely further neglected. Diocese records note that a severe storm destroyed the roof in the 1880s, and the Richardson photograph (Plate 19) suggests not only a missing roof but part of a missing west wall as well.

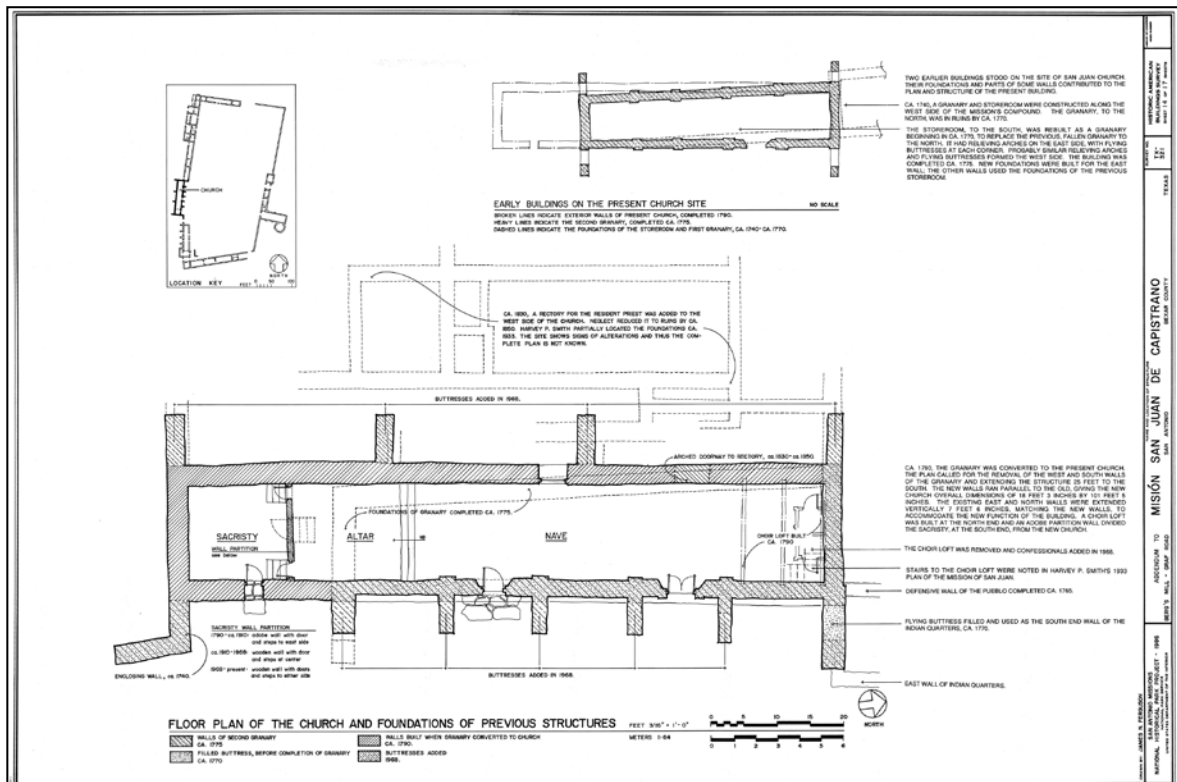
Smith Sr. and colleagues' work documenting Mission San Juan de Capistrano laid the basis for the Historical Architectural Building Survey (Plate 21). Subsequent HABS documentation of the chapel (HABS 1983)(Plate 22) has provided archaeological analysis regarding the history of the structure.

HABS 1983 addenda propose that the present chapel was built in multiple phases during the C18 and C19, over the footprint of an earlier structure located at the west side of the mission plaza (Appendix C: Sheet 14). HABS documents also propose that the blocked arch in the west elevation represents a

Plate 22. Annotated 1983 HABS drawing with remarks regarding archaeological history of present chapel. Courtesy Library of Congress. Prints and Photographs Division. HABS TEX-321.

passage to a C18 rectory building located west of the current chapel, although no supporting functional hypothesis is proposed; perhaps based upon the proximity of the adjacent foundations.

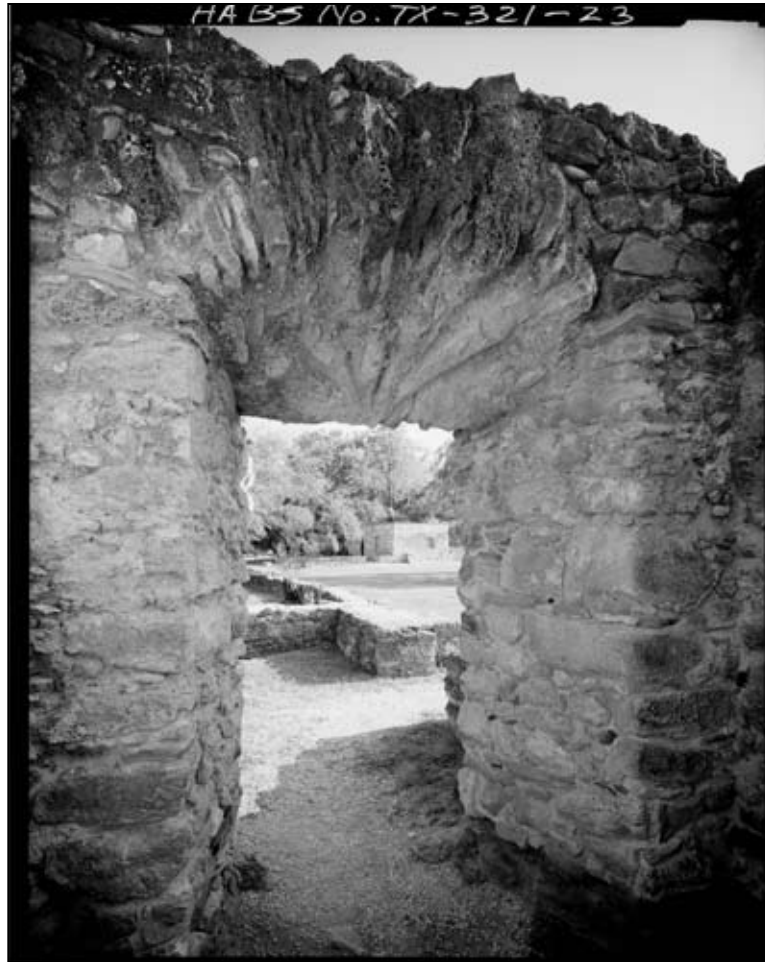
**Plate 27.** Arched doorway of 'half-finished church' baptistry looking southwest, 1983. Photograph by J. Lowe. Courtesy Library of Congress. Prints and Photographs Division. HABS TEX.15-SANT.V.3.23.

roughly proportioned sandstone and limestone. The geology of the immediate area consists of terrace deposits of sand, silt, clay and gravel in various proportions, but deposits of fine-grained sandstone and limestone lie within a few kilometers (USGS 2011). The local sources of sandstone and limestone together with the dimensions used provided for an economy of construction while likely also being products of the available tools, transport and labor-power. Original mission construction should display this type of masonry and exhibit environmental erosion from  $\approx 250$  years of exposure. The sandstone blocks in the lower area of the west elevation meet these criteria. Sections of the wall that show very diverse combinations of rubble sizes and composition suggest an area of repair or later addition, possibly using rubble that was salvaged rather than quarried.<sup>9</sup> Conversely, the masonry displayed in the buttresses is generally smaller, atypically uniform, and less weathered than C18 construction found elsewhere in the site (c.f. Plate 27).
